Contract Report CHL-97-1 March 1997

# Interaction of Seawalls and Beaches: Eight Years of Field Monitoring, Monterey Bay, California

By Gary B. Griggs, James F. Tait, Laura J. Moore, Katie Scott, Wendy Corona, Deborah Pembrook, University of California, Santa Cruz

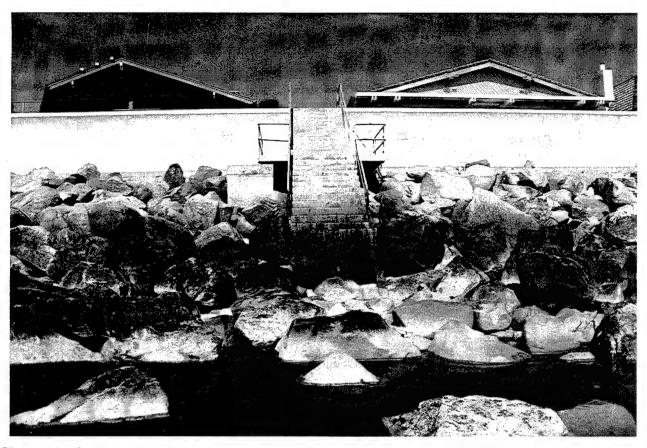
These extreme changes in beach level were reminiscent of the changes associated with the 1983 winter storms. However, despite obvious erosion, photographic comparison of the north control beach after the 1983 and 1995 events reveals that sand loss in 1995 (Figure 15b) was significantly less than it was in 1983 (Figure 15a).

Figure 14. Stairs fronting Aptos Seascape seawall after the storms of January 1995

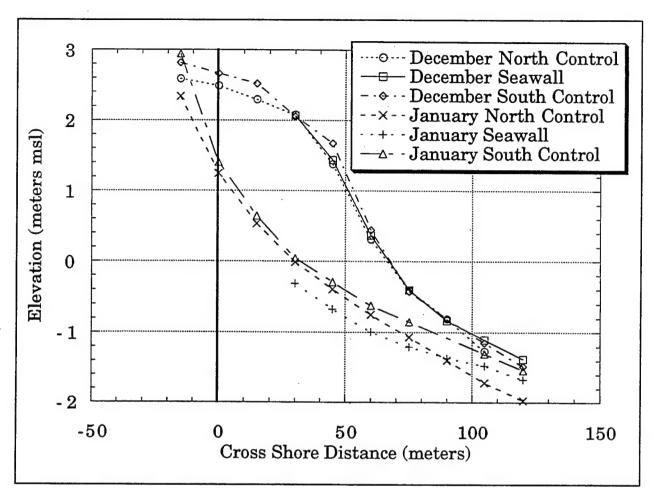
Figure 16. January and December average profiles of seawall and control beaches. The seawall runs alongshore at the zero baseline

cross-shore location for all three beaches. After the storms, however, the mean sea level intercept for the beach directly fronting the seawall had migrated landward an average of 12 m further than the intercept for the control beaches. This difference in beach width between the seawall and control beaches appears to be due to increased scour directly in front of the seawall.

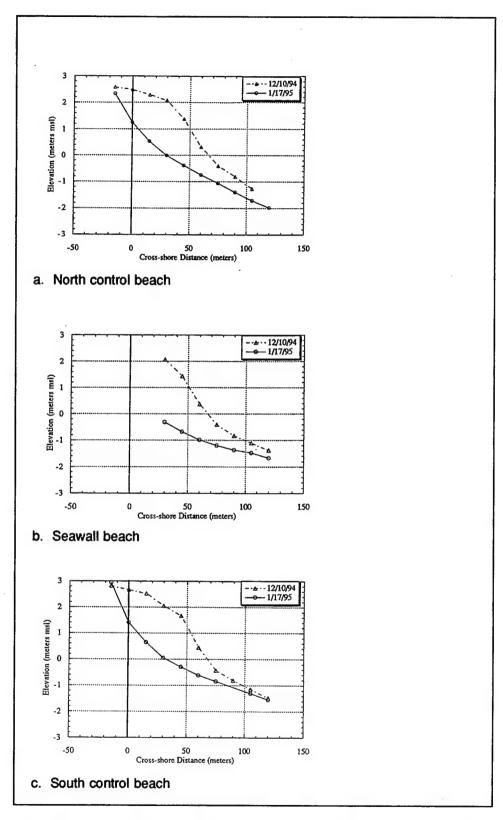
In order to quantify beach response and recovery, monthly, and when possible, biweekly surveys were conducted. Spatially averaged survey profiles indicate that the north control, seawall, and south control beaches responded almost identically to the storm waves of 1995 (Figures 16 and 17). All three beach profiles changed from an upwardly concave beach with a steep face and a fairly wide berm (wider for the control beaches because their landward extent is not limited by the seawall) to a flatter, intertidal beach face typical of post-storm profiles. In addition, while the seawall beach displayed a slightly greater change in elevation directly in front of the wall (Figure 18), the remainder of the seawall beach and the control beaches displayed comparable changes in elevation ranging from -0.5 to -2.2 m depending on cross-shore location. The average elevation change for all these beaches was approximately -1.5 m, with the greatest elevation change occurring between 15 and 30 m seaward of the baseline (the seawall).

Figure 17. Average beach profiles for north control beach (a), seawall beach (b), and south control beach (c), before and after January 1995 storms. The seawall runs alongshore at the zero baseline

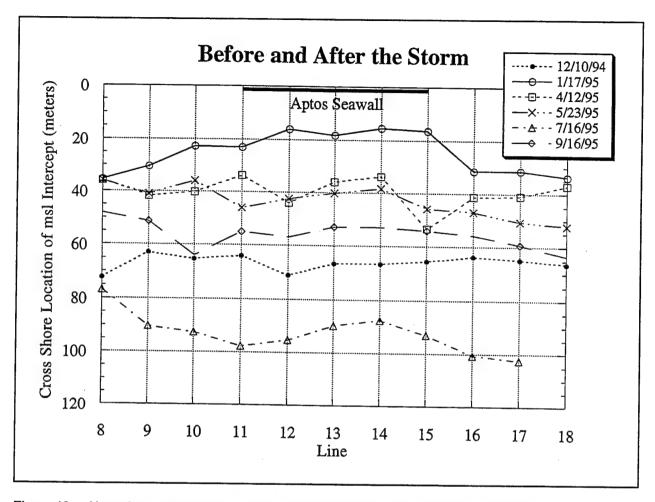
Figure 18. Alongshore differences in beach width before and after January 1995 storm

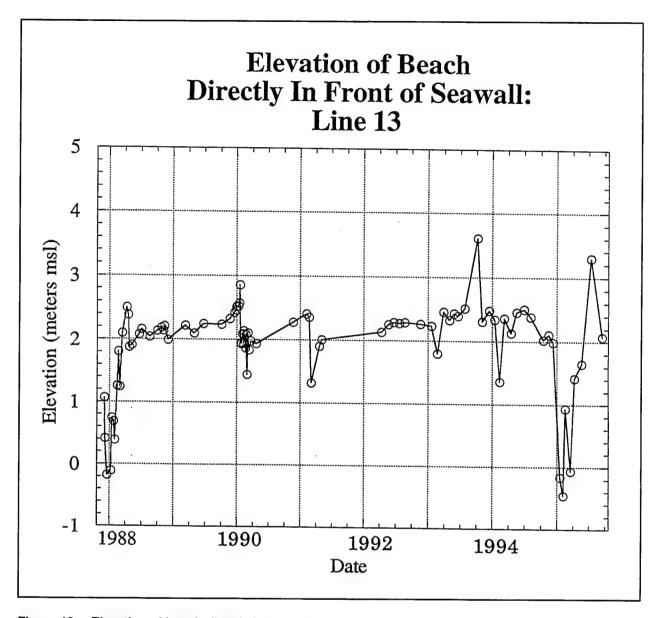
Scour depth and magnitude. The depth of scour in front of the seawall during the storms of 1995 has been ascertained by plotting the elevation of the beach directly fronting the wall. This elevation, plotted for line 13 at the center of the wall, is representative of the changes that occurred along the remainder of the seawall (Figure 19).

Scour depth during January 1995 reached an elevation of 0.4 m below msl. A scour depth of 0.2 m below msl was reached in 1987; however, it is the magnitude of scour, or net change in beach elevation between surveys, which distinguishes these two winters (Figure 20). The most significant change during the monitoring period was the -2.2-m change that occurred from December 1994 to January 1995.

Figure 19. Elevation of beach directly in front of the Aptos Seascape seawall between 1987 and 1995

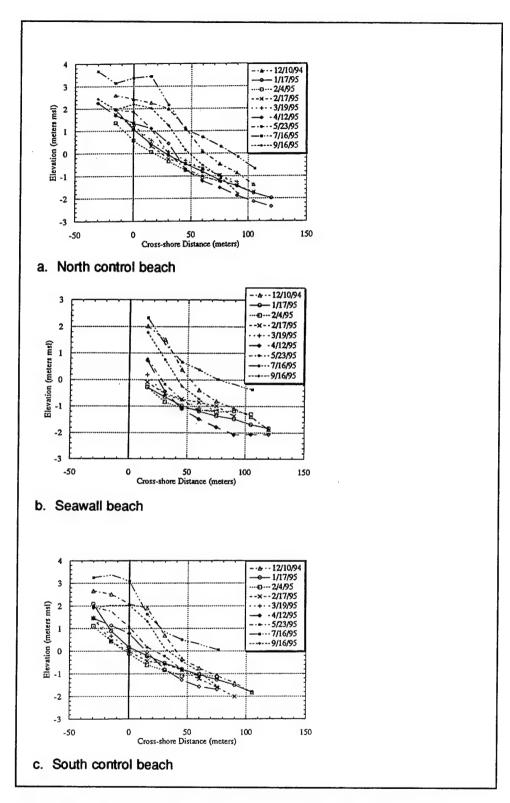
Figure 20. Beach recovery: Average profiles of a), north control beach, b) seawall beach, and c) south control beach from December 1994 to September 1995. The seawall runs alongshore at the zero baseline

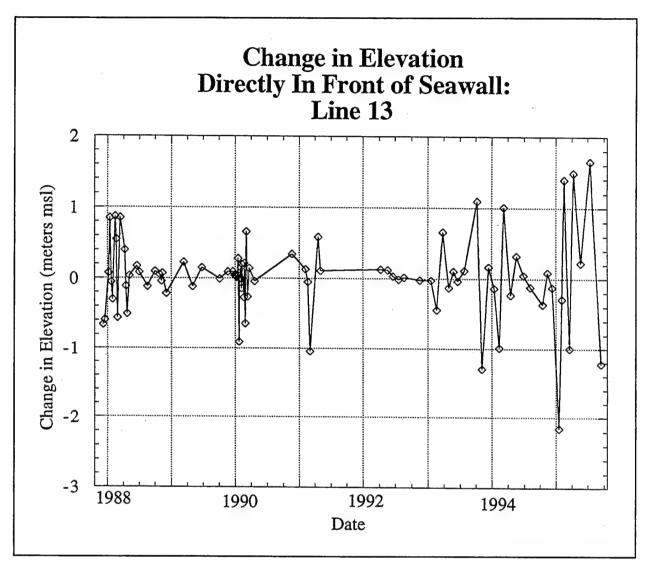
Figure 21. Change in elevation of beach directly in front of Aptos Seascape seawall between surveys 1986-1995

After the initial January storm, which caused the most drastic changes of the season, the Aptos Seascape beach profiles continued to lower slightly, as waves pounded at the newly created dissipative profile. This continued erosion is apparent in the profiles from the survey in early February (Figure 21). However, despite the significant changes in profile geometry, beach width, and scour depth that occurred during January and early February, the third poststorm survey taken in mid-February reveals that deposition had occurred, and that the seawall and control beaches had quickly begun to recover (Figure 21).
